LETTER TO THE EDITOR

Ann. Ital. Chir., 2013; 84: 483-484

The use of oxidized regenerated cellulose in oncoplastic breast surgery: “warning” for postoperative follow-up!

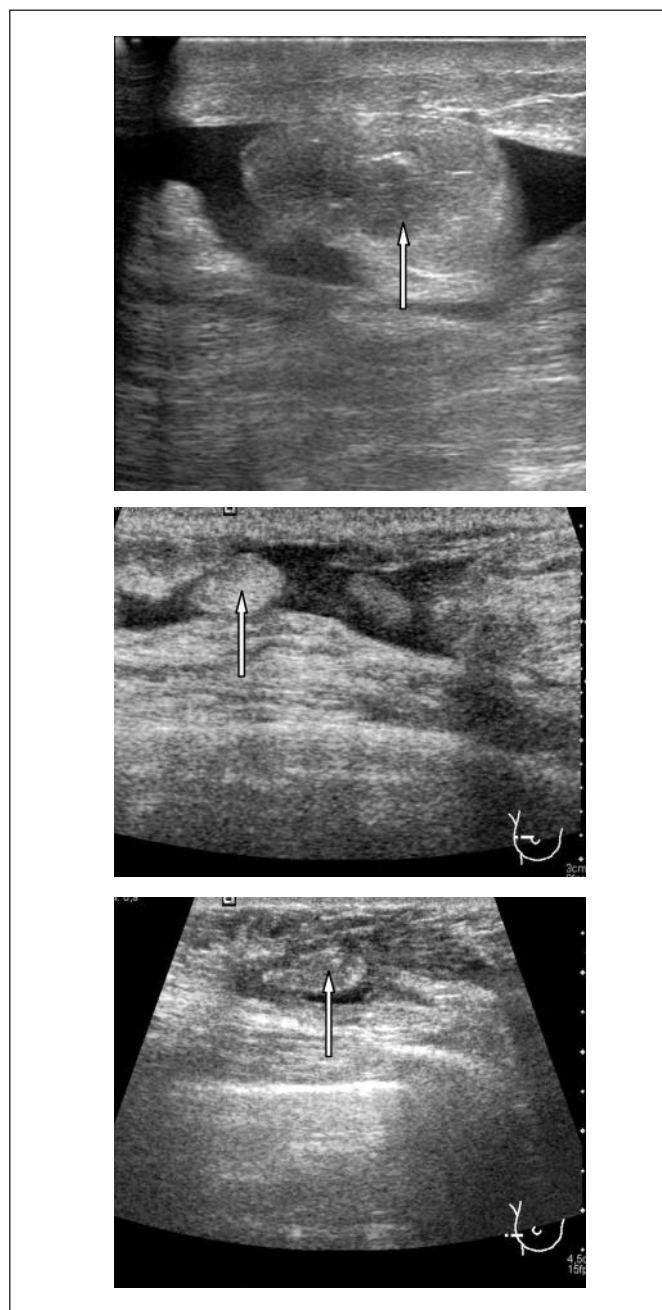
Ultrasound images (Siemens Antares sonography unit, Siemens Medical Solutions, Sweden) at six-month follow-up in three patients treated by breast oncoplastic conservative surgery with ORC.

With the use of a high-frequency 10–13 MHz linear array transducer, a free anaechoic collection without wall with the presence of typical small hyperechoic round masses (yellow arrow) in continuity with the breast parenchyma is showed.

As concerns postoperative imaging, peculiar signs were always observed on breast ultrasound examination (US), performed six months after surgery. As consequence of the fibrogenetic action induced by ORC and of the partial reabsorption of this biomaterial, fluid anaechoic

accumulation containing small hyperechoic, round components were documented. These typical round images, due to the presence of fibrillar material, appeared non-mobile, avascular, and adherent to the parenchymal tissue planes (Figs. 1, 2, 3) and were often interpreted in an alarming way by the radiologists. The diagnostic interpretations varied from possible residual disease to haematoma sequale, local abscess or area of fat necrosis.
